City of Wilmington Pedestrian Safety Study

Wilmington Pedestrian Audit

Kirkwood Street: 7th Street to 11th Street

July 14, 2023

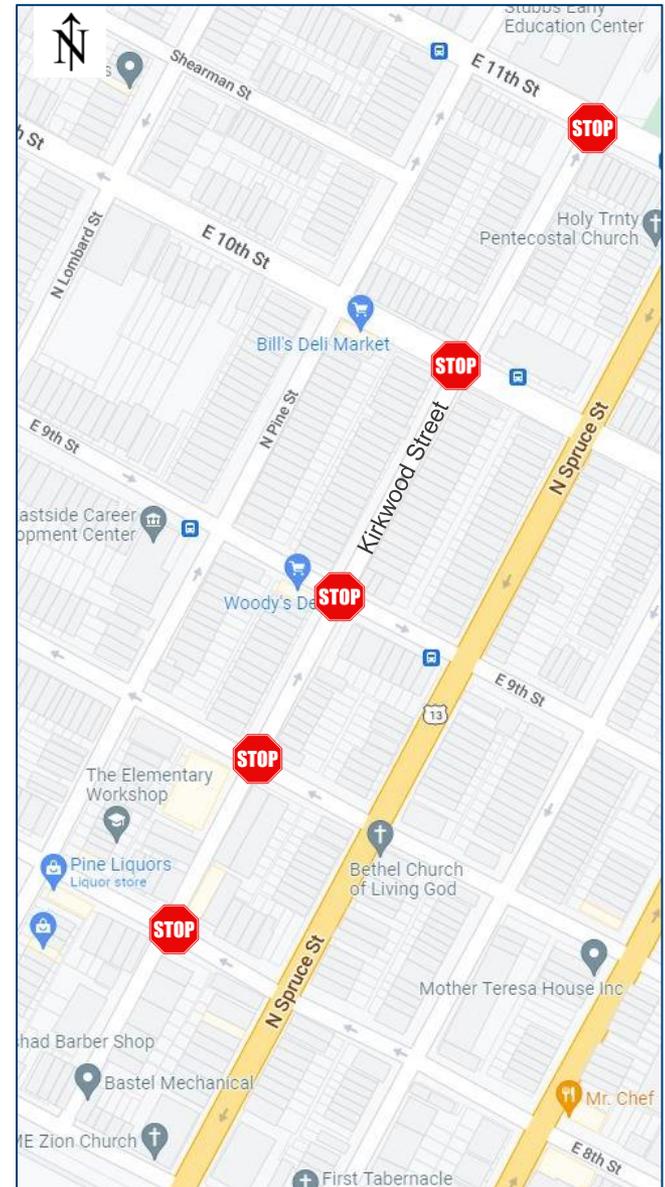
Kirkwood Street Corridor

- 0.30-mile local roadway
- 2019 AADT < 1,000
- One-way roadway with NB traffic
- One through lane, ~10 ft width
- Curb-to-curb crossing distance ~26 ft
- On-street parking on both sides of the roadway
- Sidewalks and lighting present
- 25-MPH speed limit
- 6 unsignalized intersections
- Unsignalized mid-block parking lots and driveways between 7th Street to 8th Street and 10th Street to 11th Street

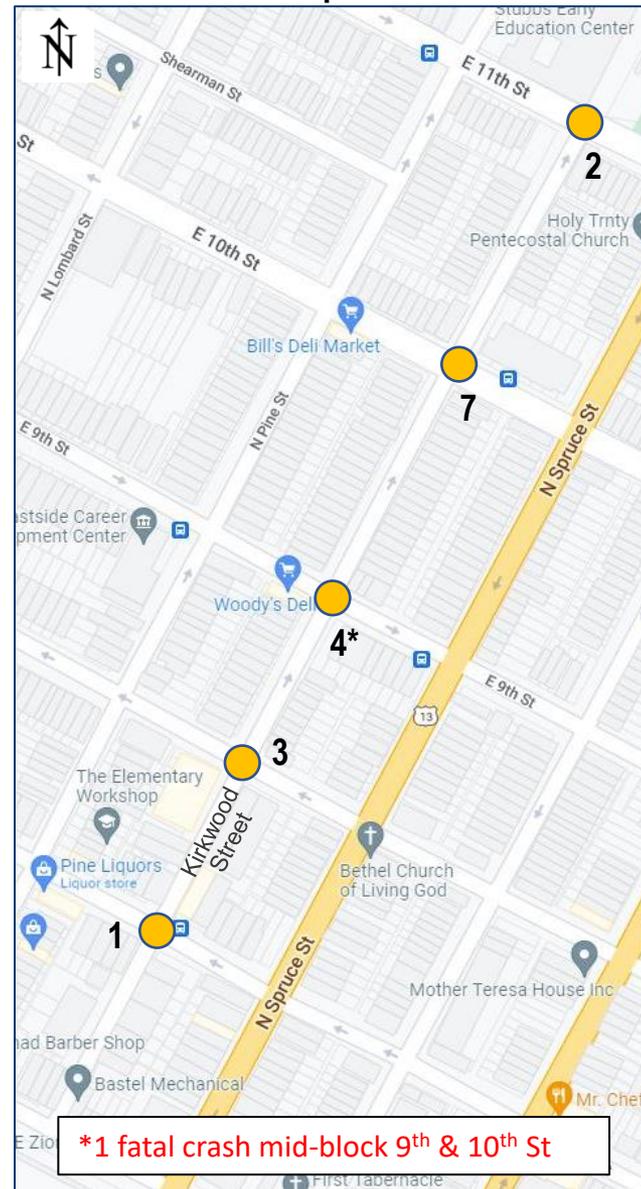
Lighting Assessment

- Qualitative driving assessment
- Streetlamps and LED luminaires are common
- Midblock coverage strong
- Lighting deficient at 4 intersections:
 - 7th street – East and West legs
 - Taylor Street – East leg
 - 9th Street – North, West, and South legs
 - 10th Street – East leg

- Install pedestrian crossing warning signage along all non-stop controlled approaches
- Install crosswalk striping at all intersections with existing truncated domes
- Install missing KIRKWOOD STREET signs at 7th Street and 10th Street
- Install missing 10TH STREET signs at 10th Street
- Consider installing an east and/or west crosswalk leg on 11th Street for NB and SB Kirkwood street pedestrian traffic
- Consider lighting improvements at deficient locations

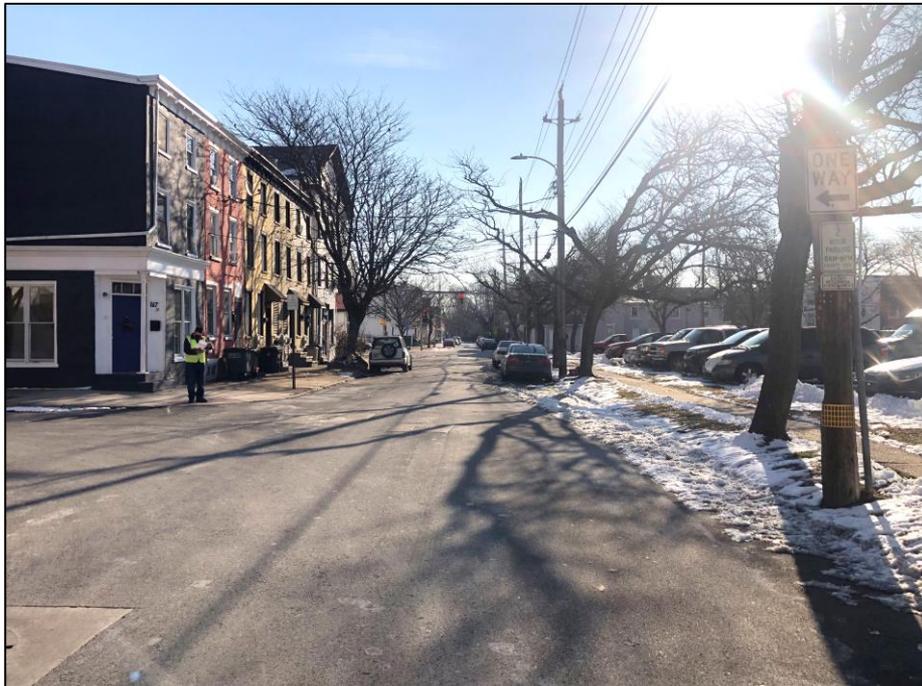
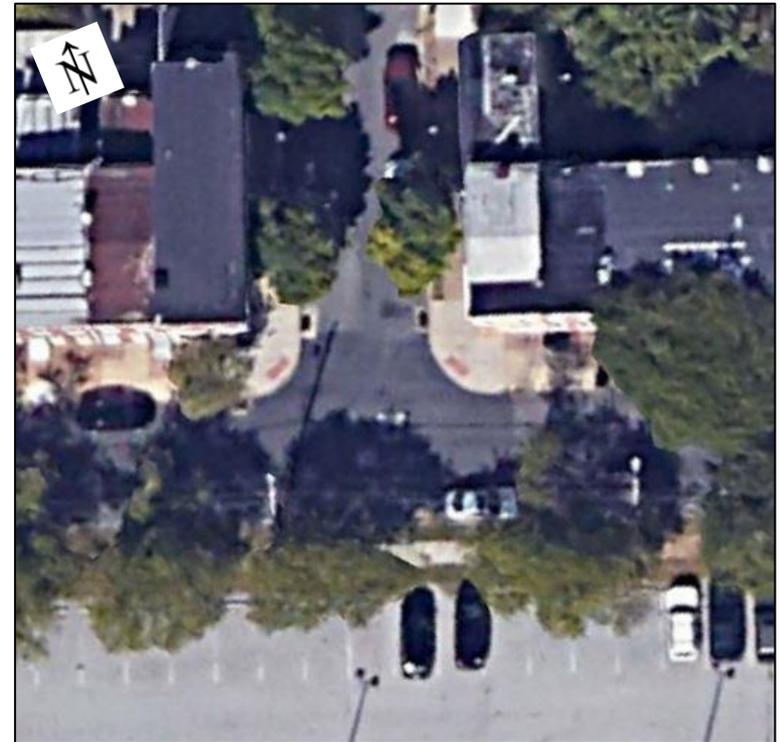
Kirkwood Street at 7th Street

- **Zero pedestrian crashes**
- Existing crosswalk domes on the north leg
- No existing marked crosswalks
- T intersection with no stop control
- Missing KIRKWOOD ST street blade signs at the intersection

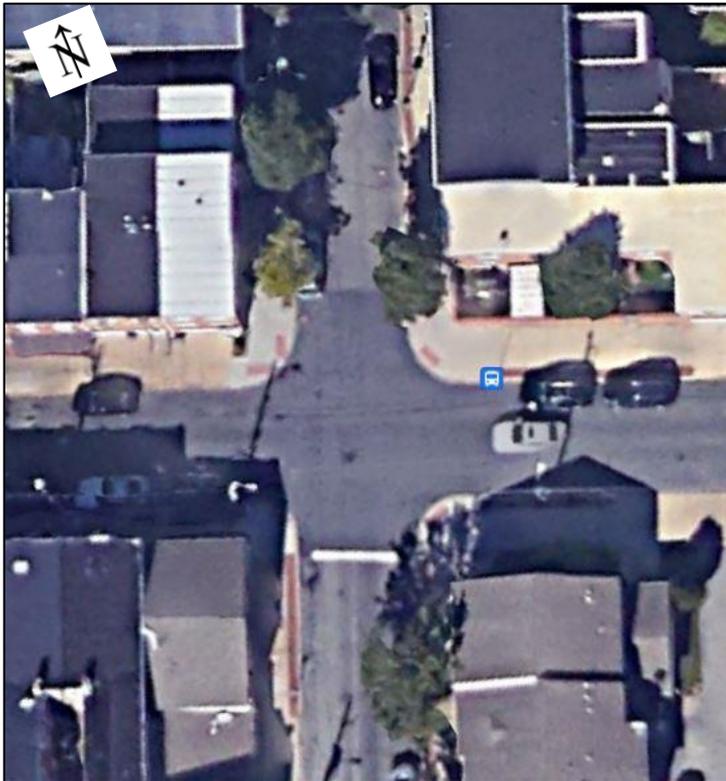
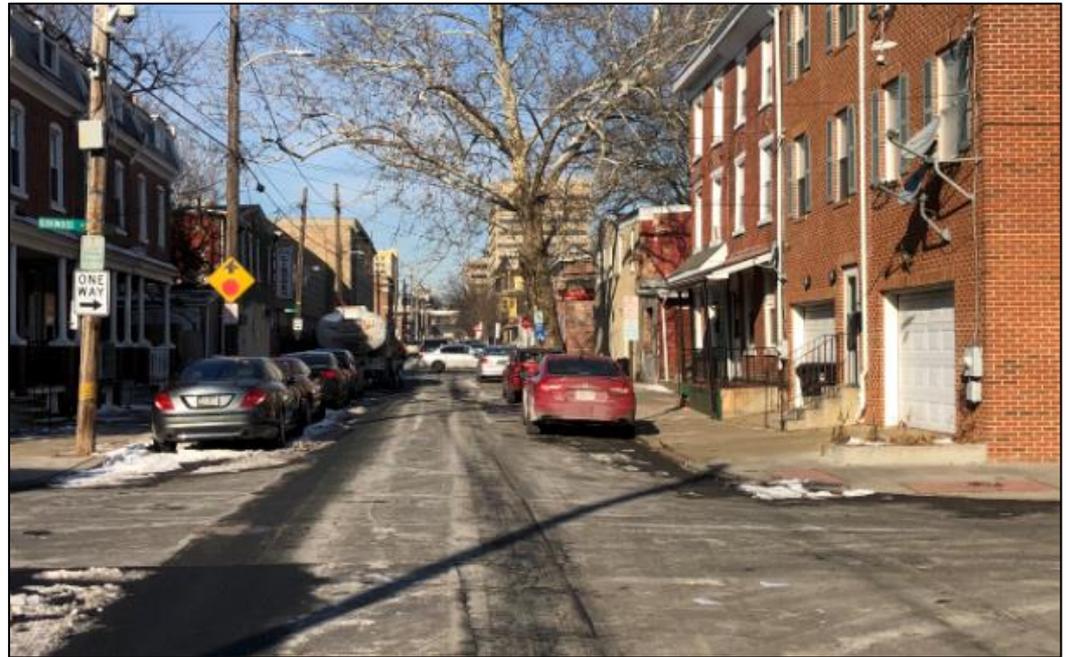
Kirkwood Street at 8th Street

- **One crash** involving a NB vehicle striking a pedestrian crossing midblock
- Existing crosswalk domes on all legs
- No existing marked crosswalks
- NB approach is stop controlled

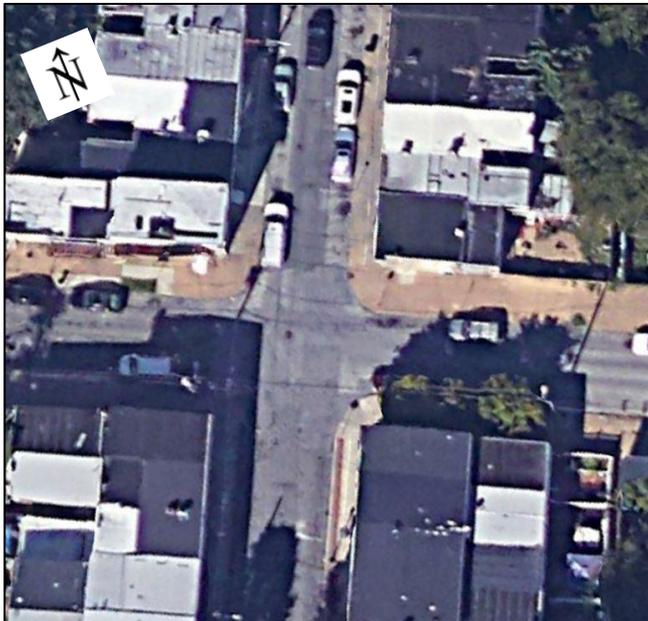
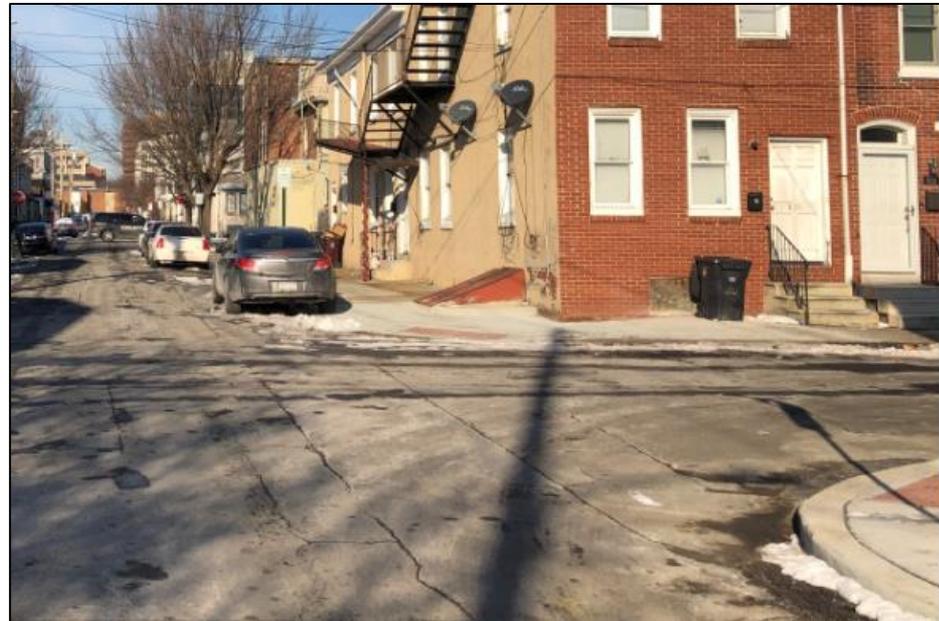
3 crashes

- 1 crash involving two NB vehicles striking a pedestrian as a result of a rear-end crash
- 2 crashes involving a NB vehicle exiting a parking spot and striking a pedestrian crossing midblock
- Existing crosswalk domes on all legs
- No existing marked crosswalks
- NB approach is stop controlled

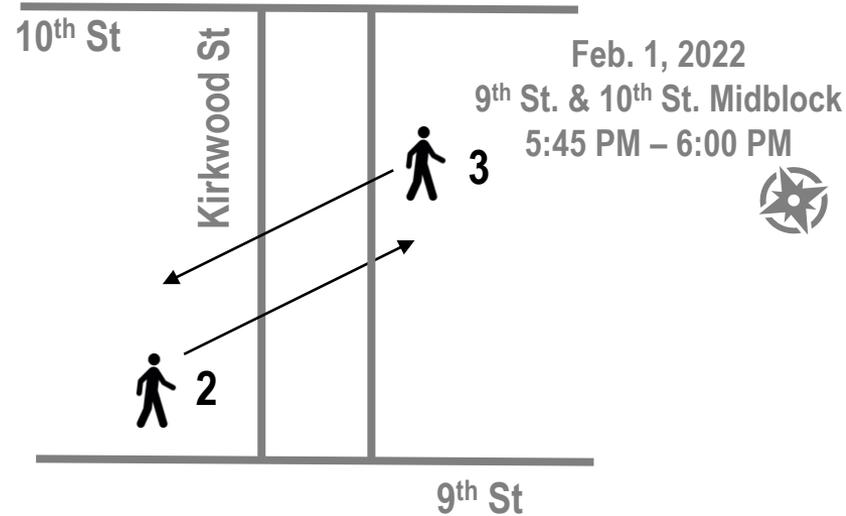
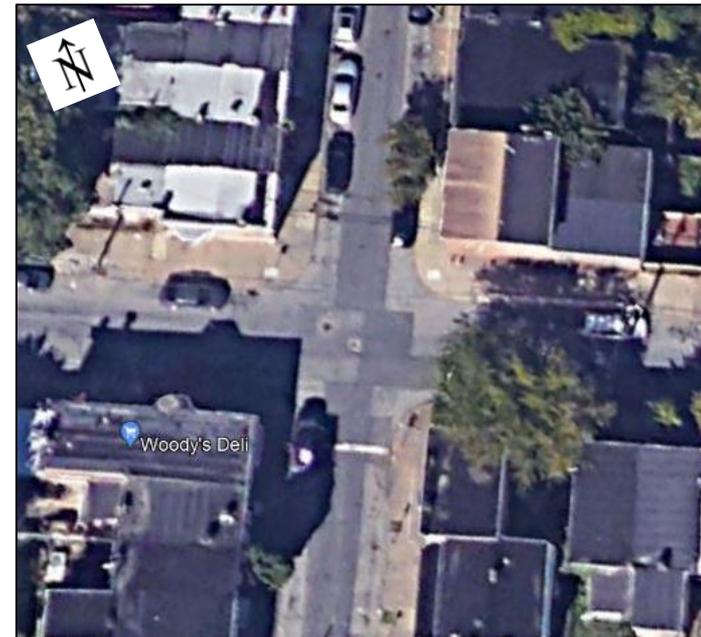
Kirkwood Street at 9th Street

4 crashes

- 2 crashes involving a NB vehicle striking a pedestrian (1 in the crosswalk)
- 1 crash involving a NBR vehicle striking a pedestrian crossing the south leg
- 1 crash involving a pedestrian (child) darting into the roadway and being struck by a NB vehicle (FATAL)
 - Wednesday, October 10, 2018, at 5:55 PM
- Existing crosswalk domes on all legs
- No existing marked crosswalks
- NB approach is stop controlled

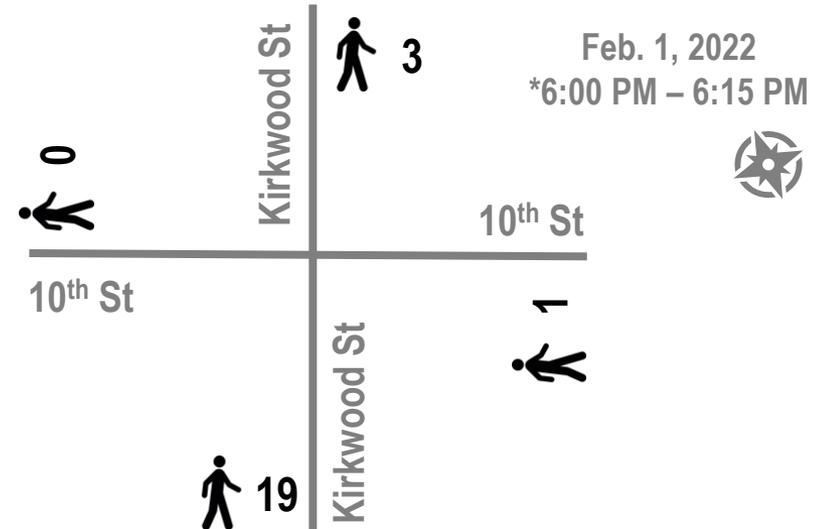
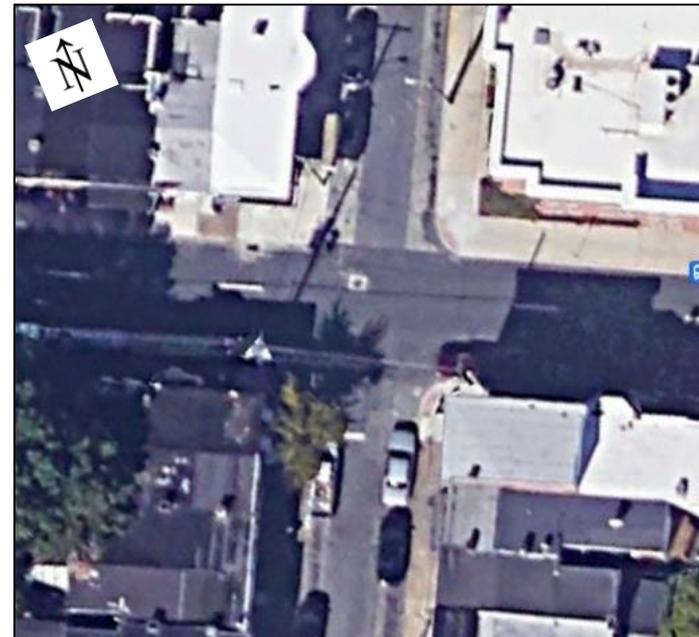
7 crashes

- 4 crashes involving a pedestrian crossing midblock between parked cars and being struck by a NB vehicle
- 2 crashes involving a NB vehicle striking a pedestrian in the crosswalk
- 1 crash involving a pedestrian entering the crosswalk and striking the side of a WB vehicle
- Existing crosswalk domes on the north leg
- No existing marked crosswalks
- NB approach is stop controlled
- Missing KIRKWOOD STREET and 10TH STREET street blade signs at the intersection
- During field observations, there was a crash at Pine Street at 10th Street, potentially increasing area pedestrian traffic

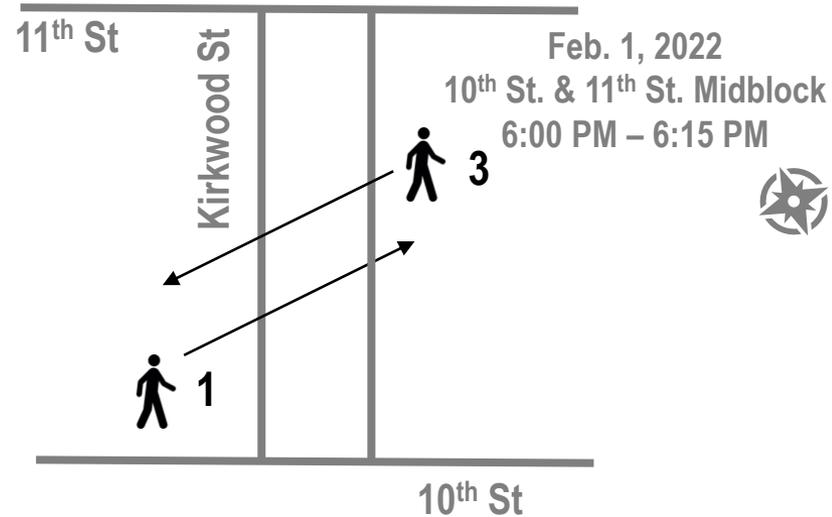
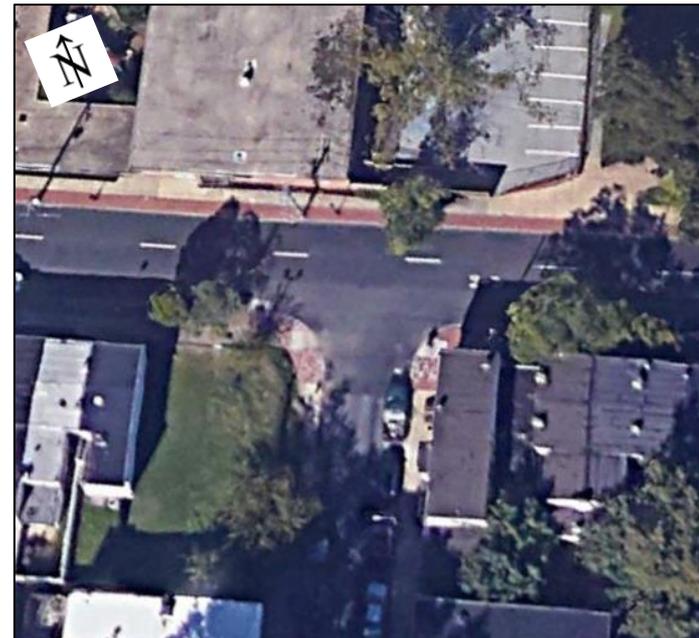
- **2 crashes** involving a pedestrian crossing the unmarked east/west leg and an EB vehicle striking the pedestrian

- Existing crosswalk domes on the south leg
- No existing marked crosswalks
- NB approach is stop controlled
